# **Technical Report:** **March 2008 Groundwater** **Monitoring Program Results and** **Baseline Ecological Risk Assessment**

**Former JCI Stanley Tools Site**  
**Fowlerville, Michigan**

**April 2008**

# SEMI-ANNUAL GROUNDWATER SAMPLING RESULTS REPORT

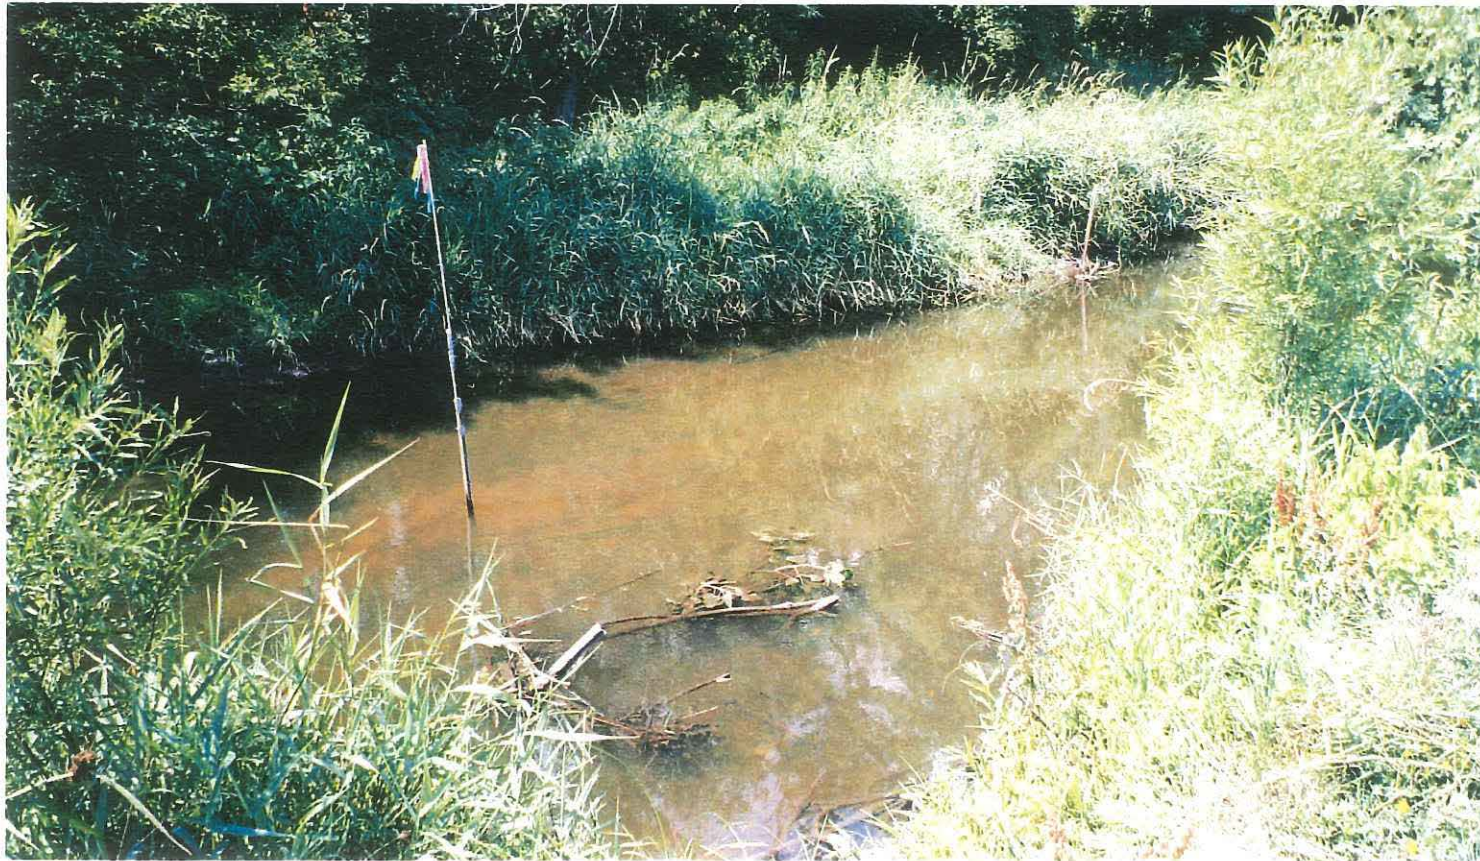
PHOTO 8

SUBJECT: Location of sediment sample SD-E3-003. Area of community survey Station 03 was located approximately 15 feet downstream (N). Looking NW.

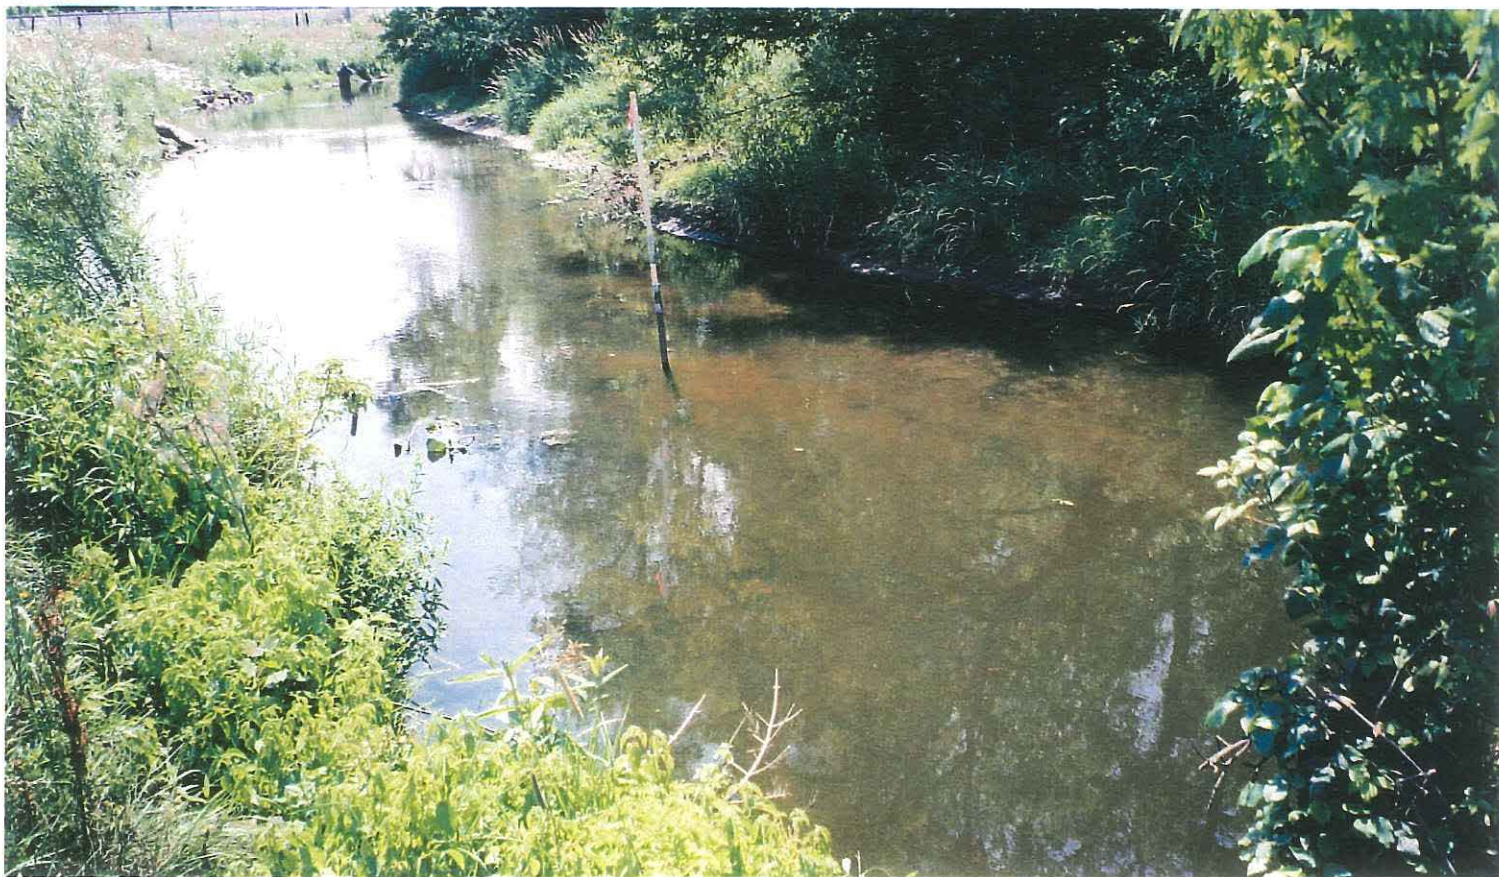
PHOTO 9

SUBJECT: Location of sediment sample SD-E3-003. Area of community survey Station 03 located approx. 15 feet downstream (north), in foreground. Looking SW.

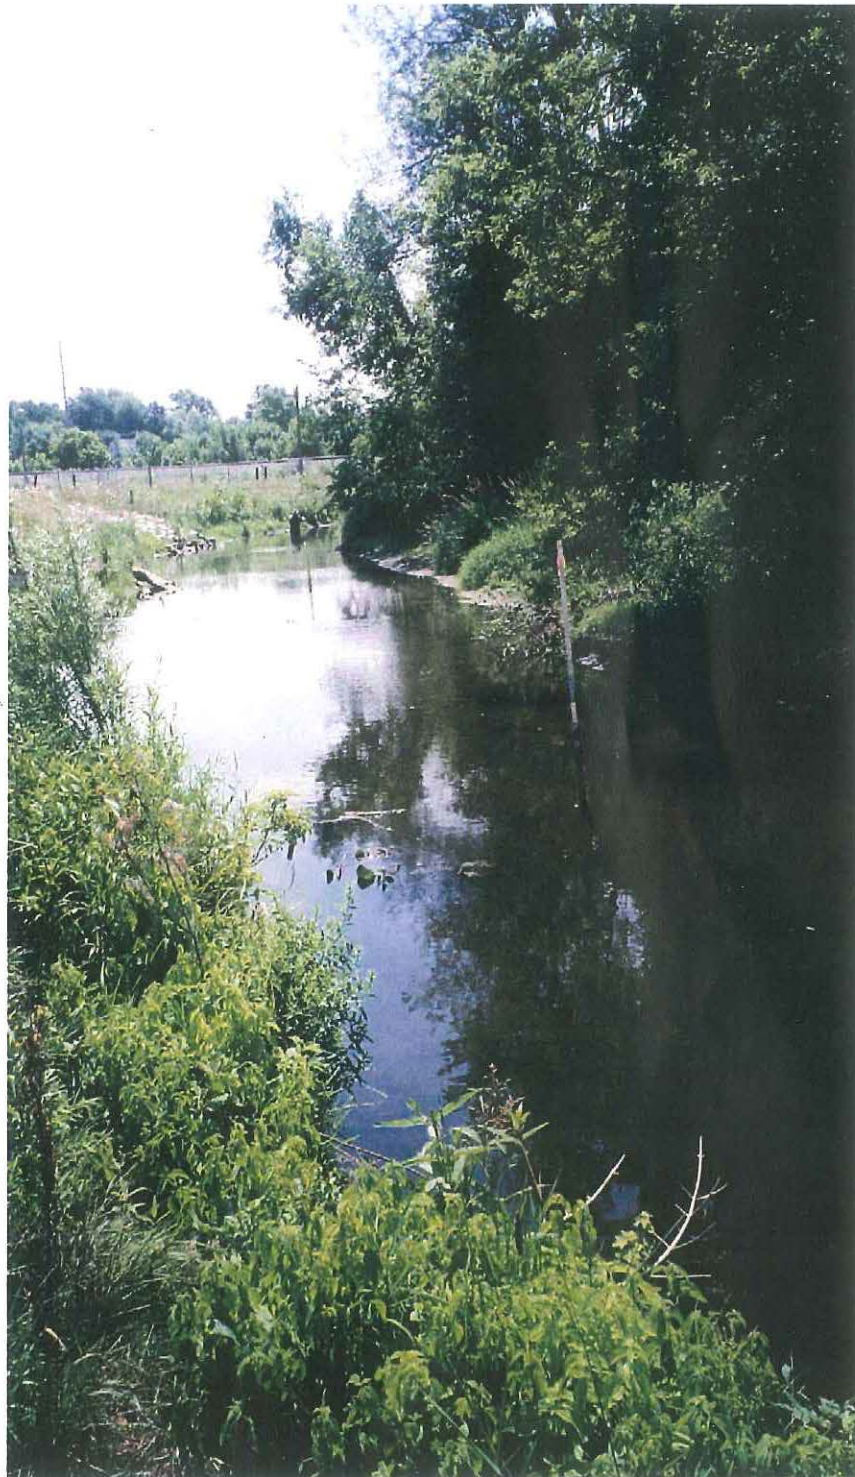
PHOTO 10  
DATE: July 24, 2007  
SUBJECT: Location of sediment sample SD-E3-003. Sampling at SE/RE-3/3-004 occurring in background. Looking S..

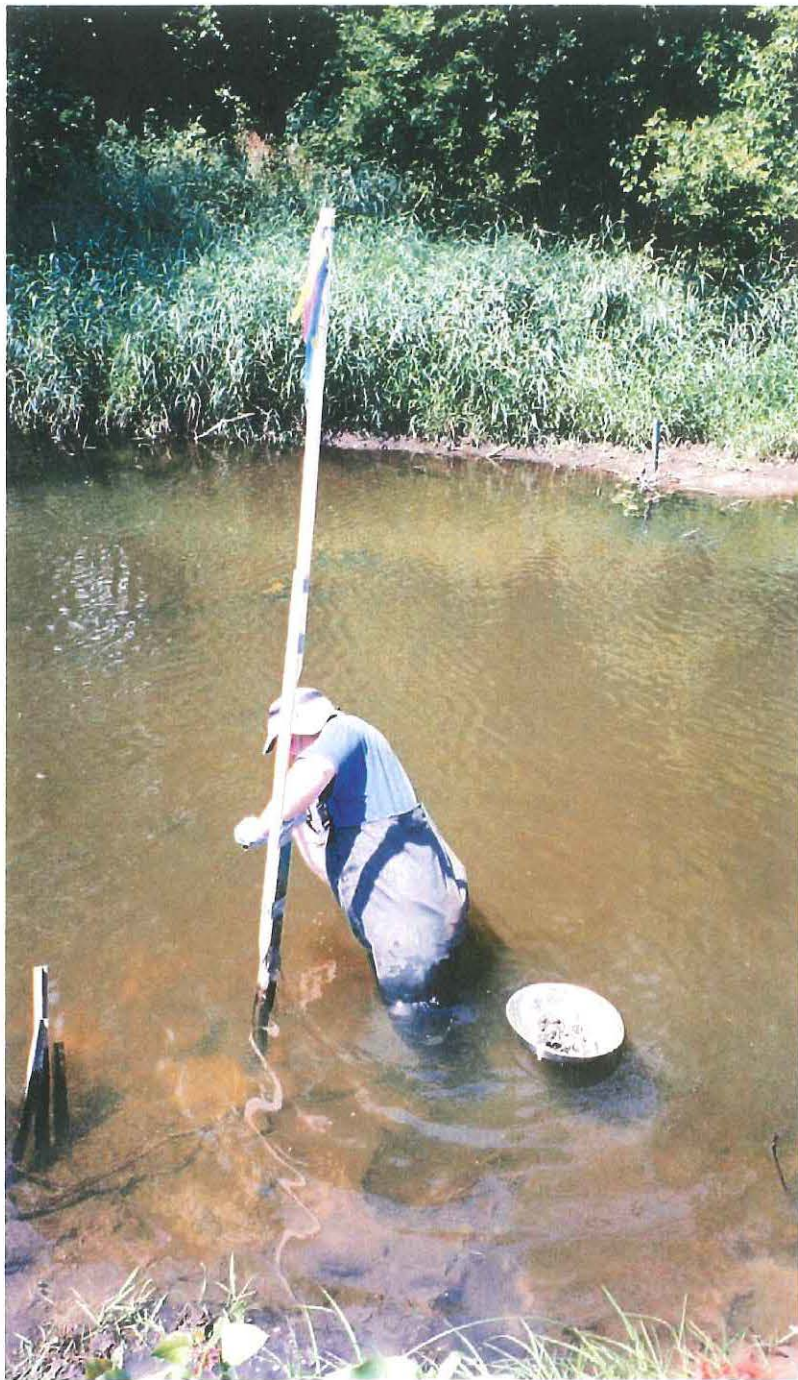
PHOTO 11

SUBJECT: Collecting sediment sample SD-C1-005. Looking W.

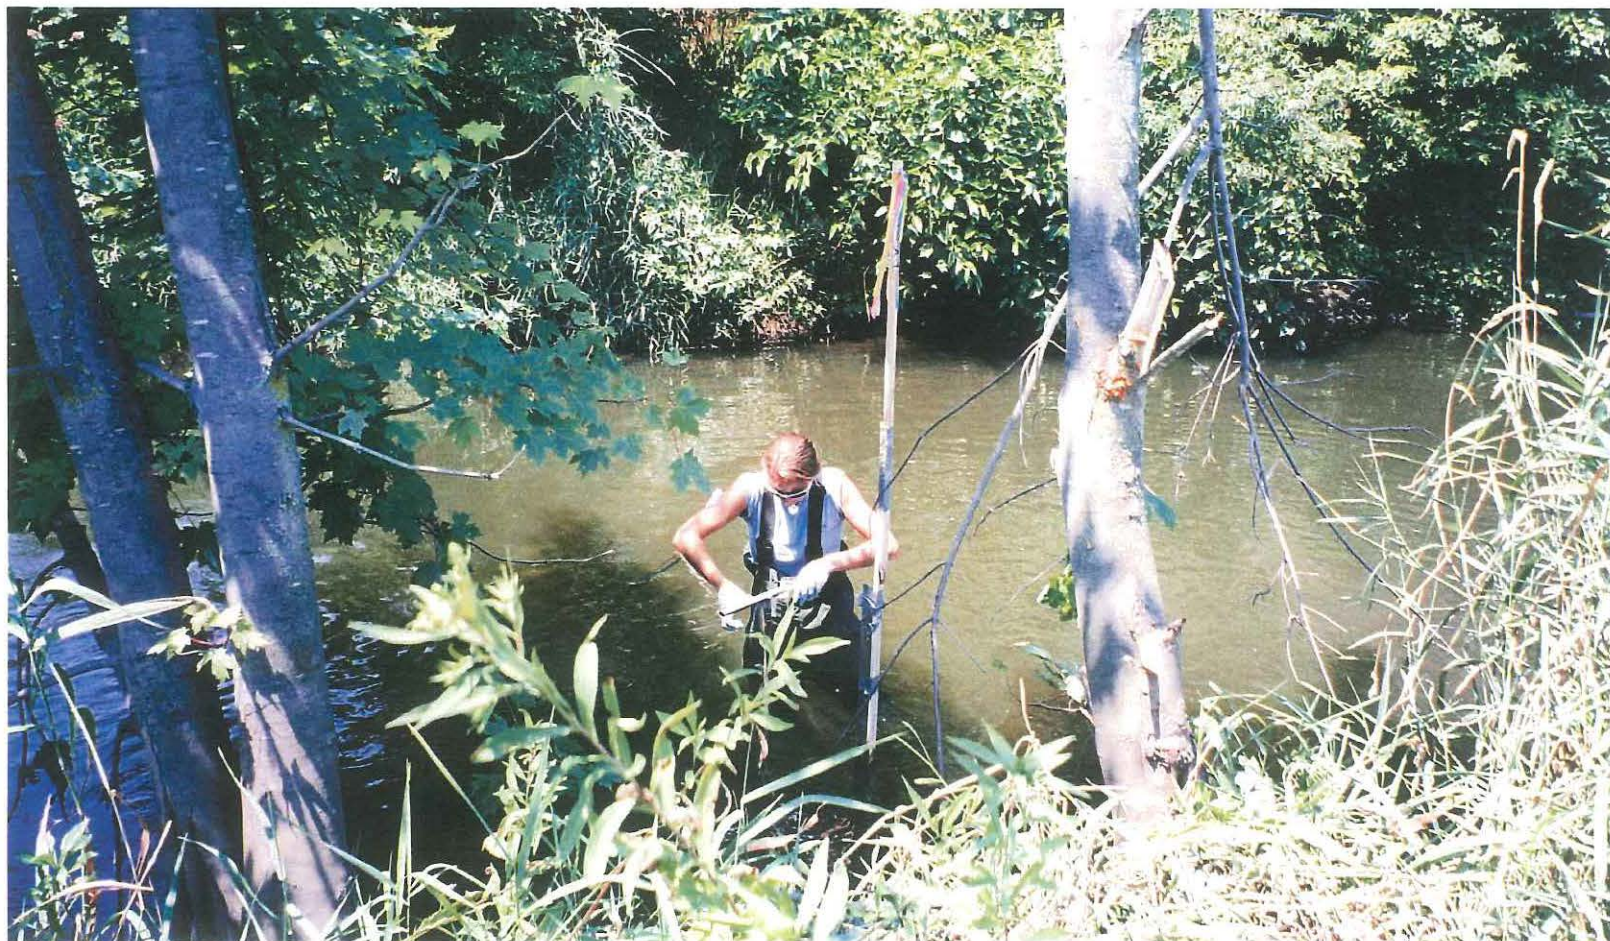
PHOTO 12

SUBJECT: Collecting sediment sample SD-A1-006. Looking W.

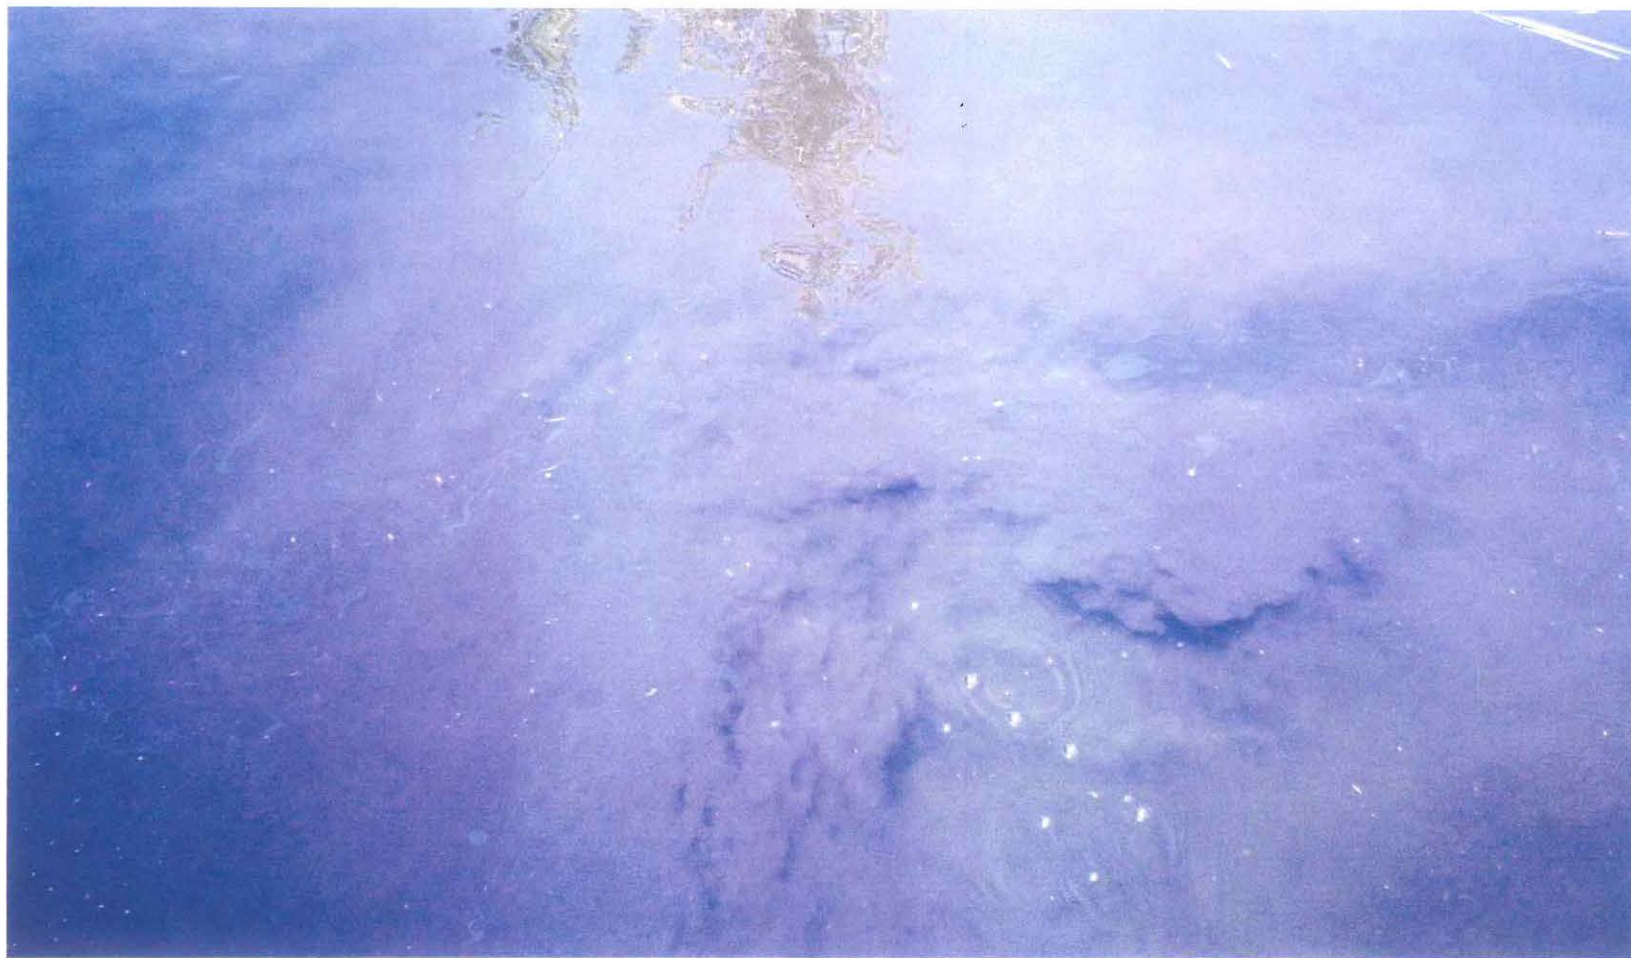
PHOTO 13

SUBJECT: Oily sheen on water after collecting sediment samples at SD-E2-003.

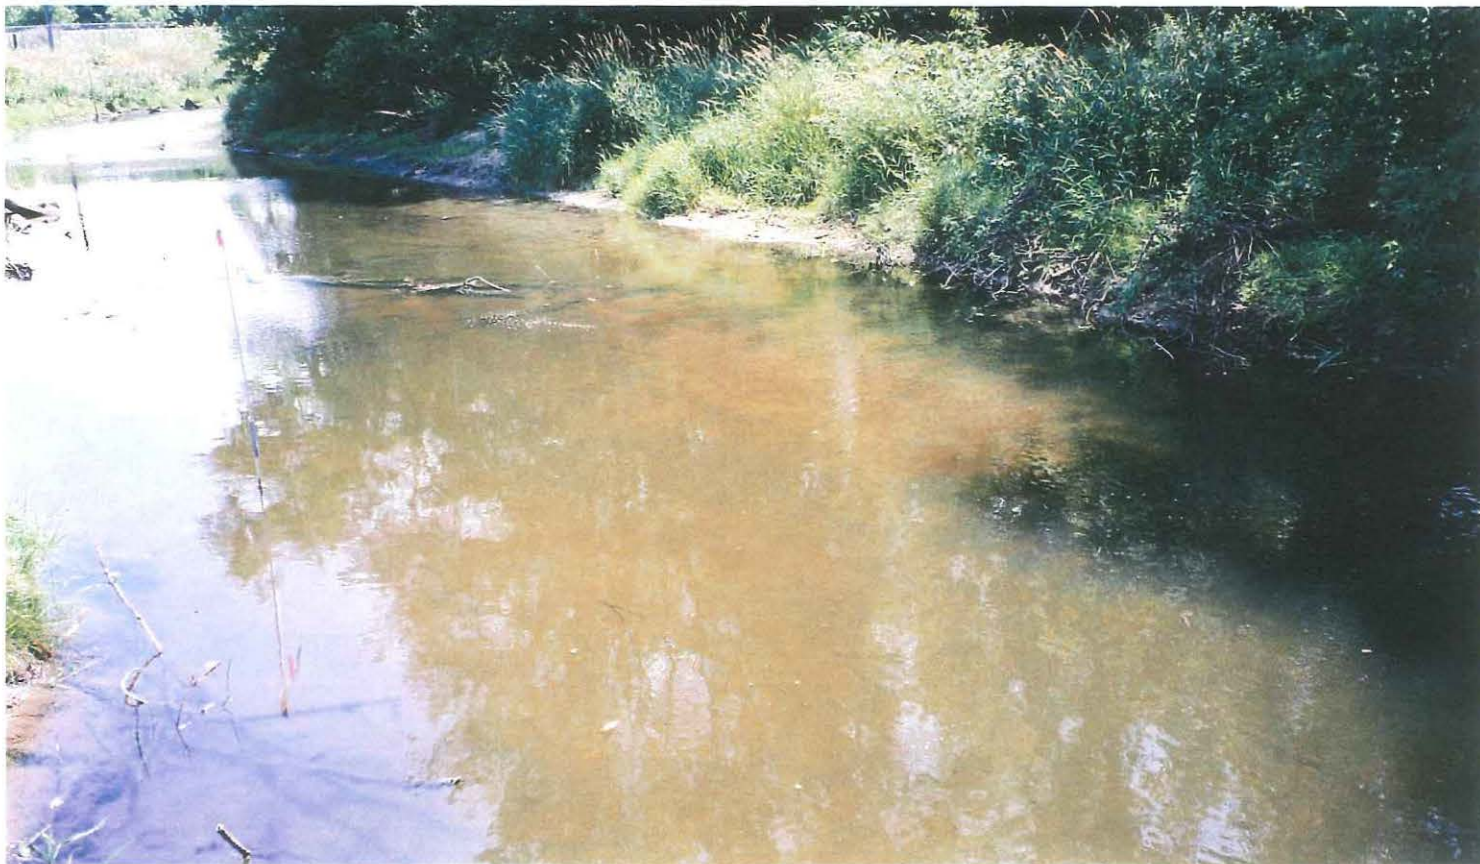
PHOTO 14

SUBJECT: Location of community survey Station 04, approx. 20 feet downstream (north) of sample SE-RE-3-3-004 (stake in river, left side of photo). Looking SSW.

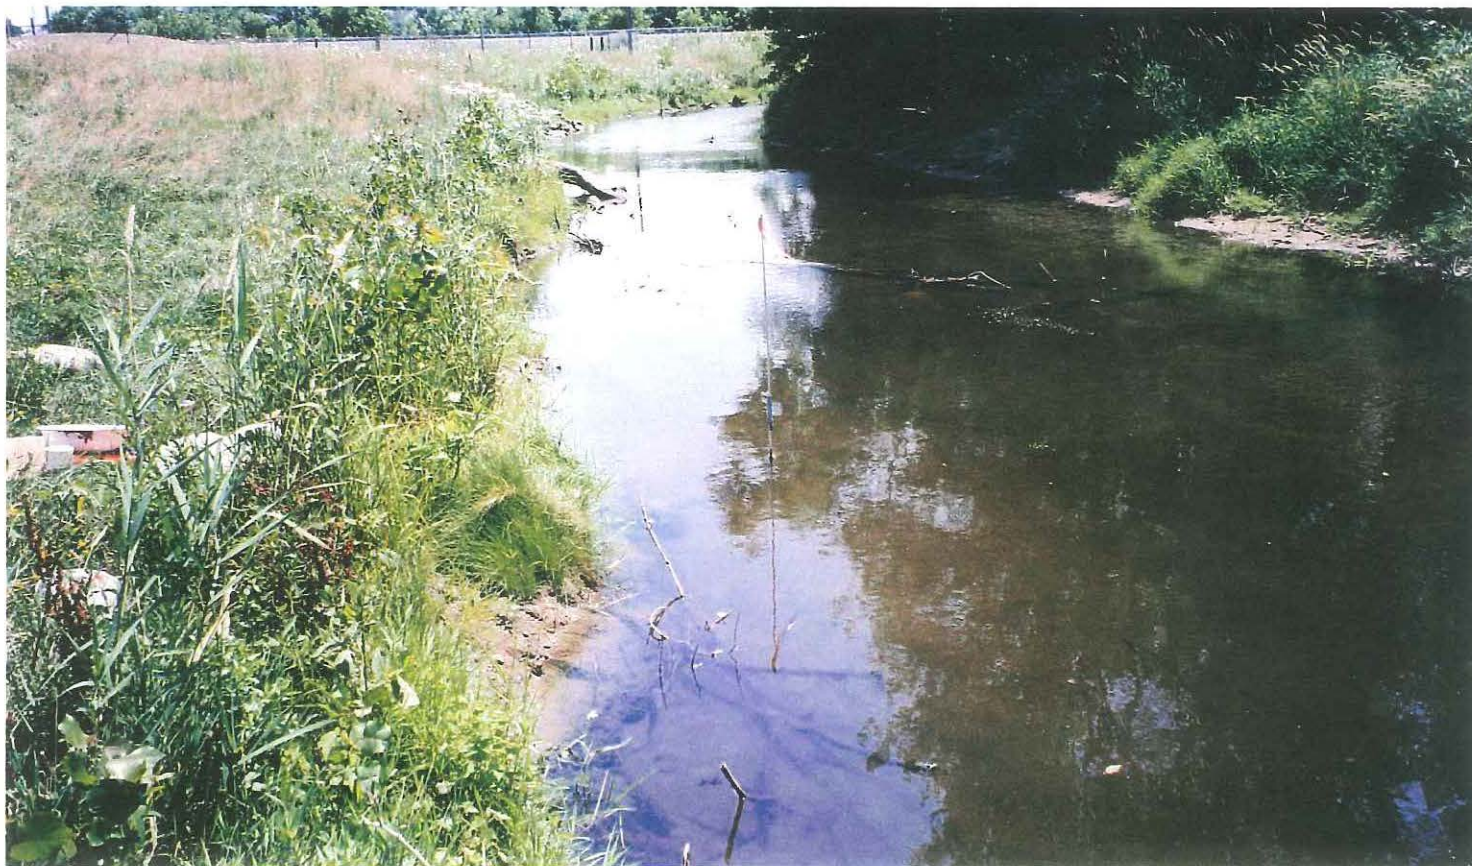
PHOTO 15

SUBJECT: Location of community survey Station04, approx. 20 feet downstream (north) of sediment sample SE-RE-3-3-004 (stake in river, center of photo). Looking S.

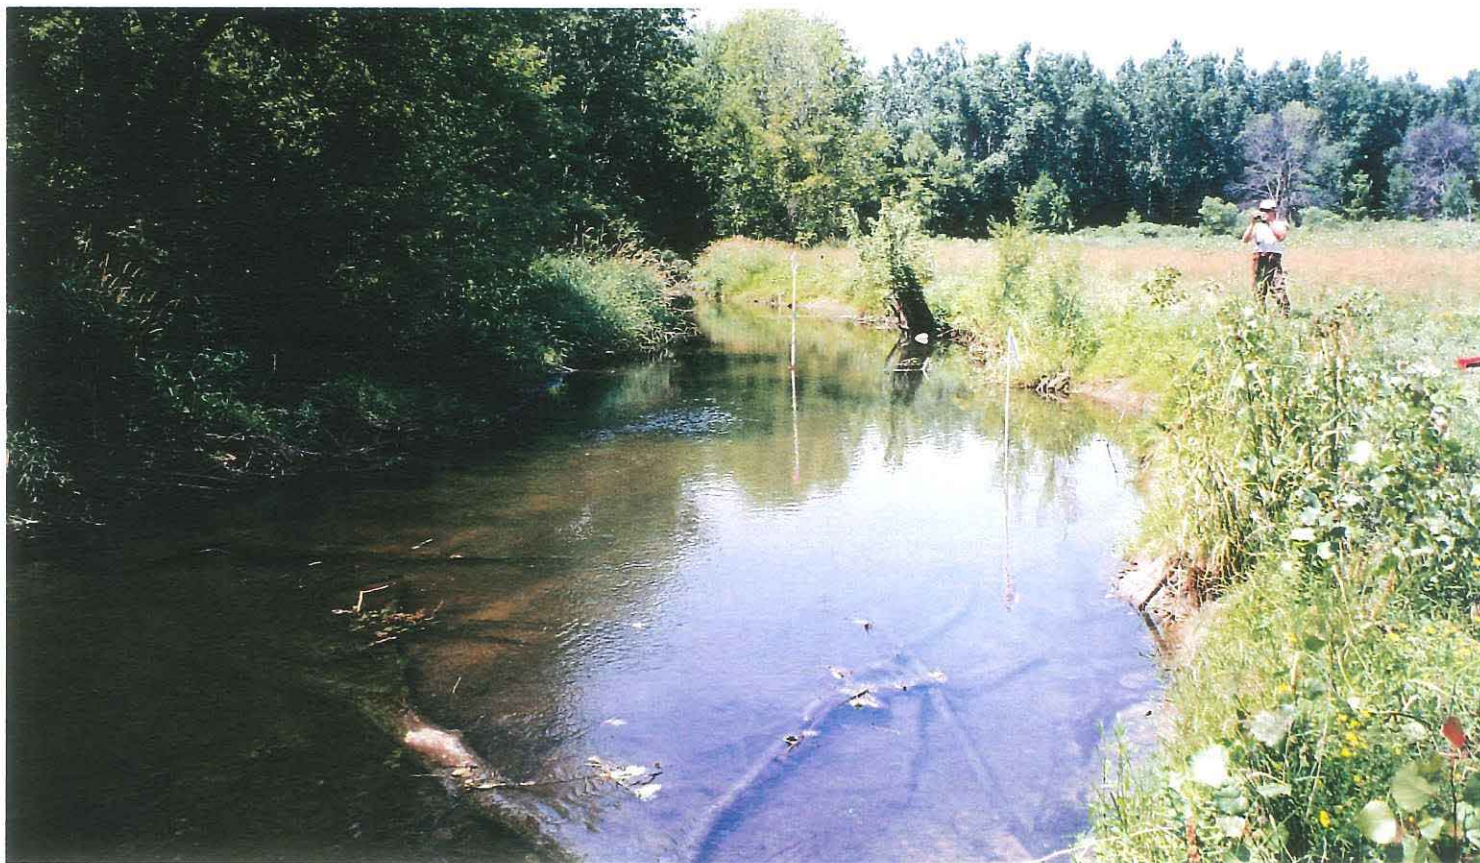
PHOTO 16

SUBJECT: Location of community survey Station 04, approx. 20 feet downstream (north) of sample sediment SE-RE-3-3-004 (near stake in river). Location of sediment sample SD-E2-003 at stake in background. Looking N.

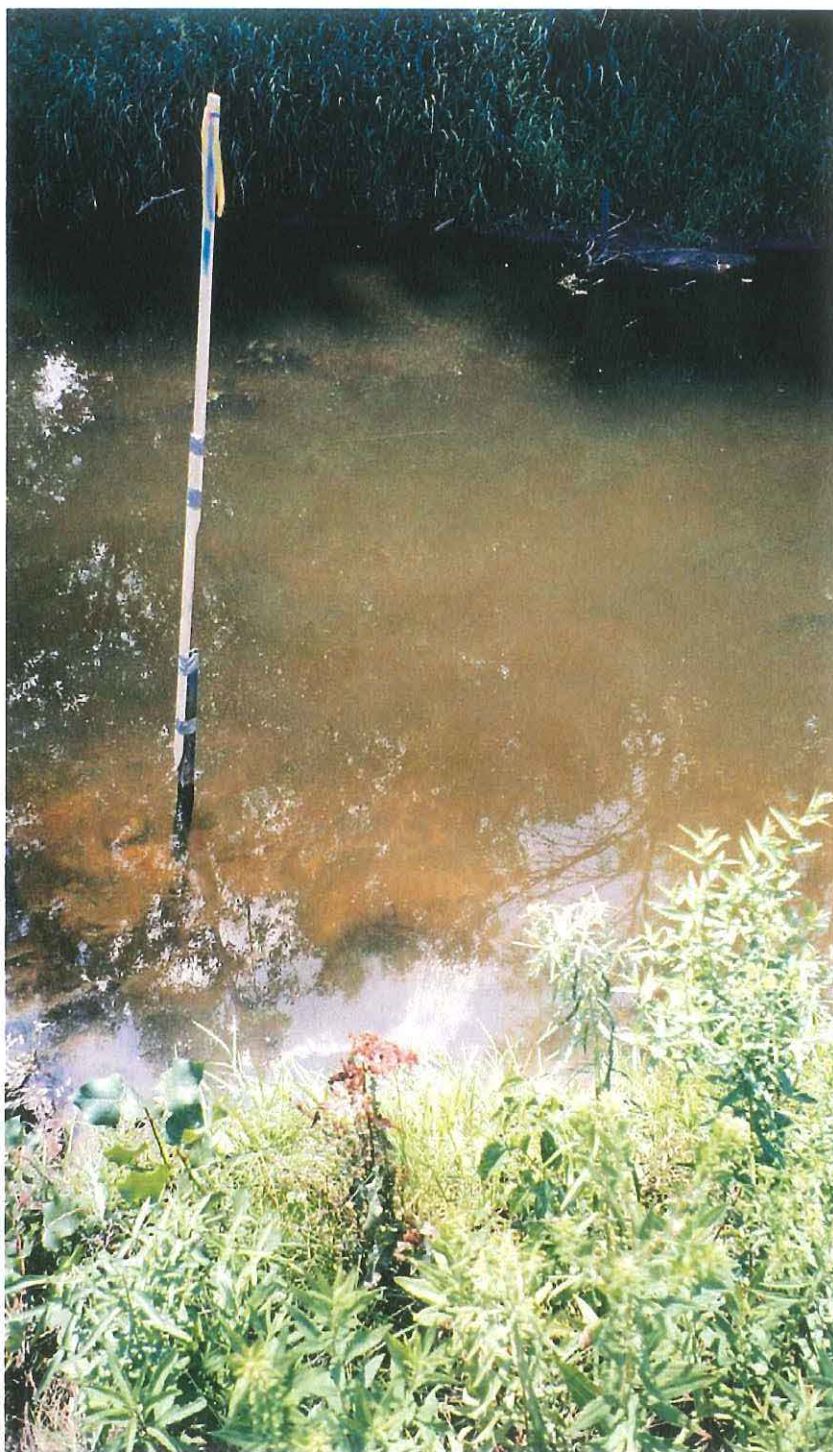
PHOTO 17

SUBJECT: Location of sediment sample SD-C1-005. Looking W.

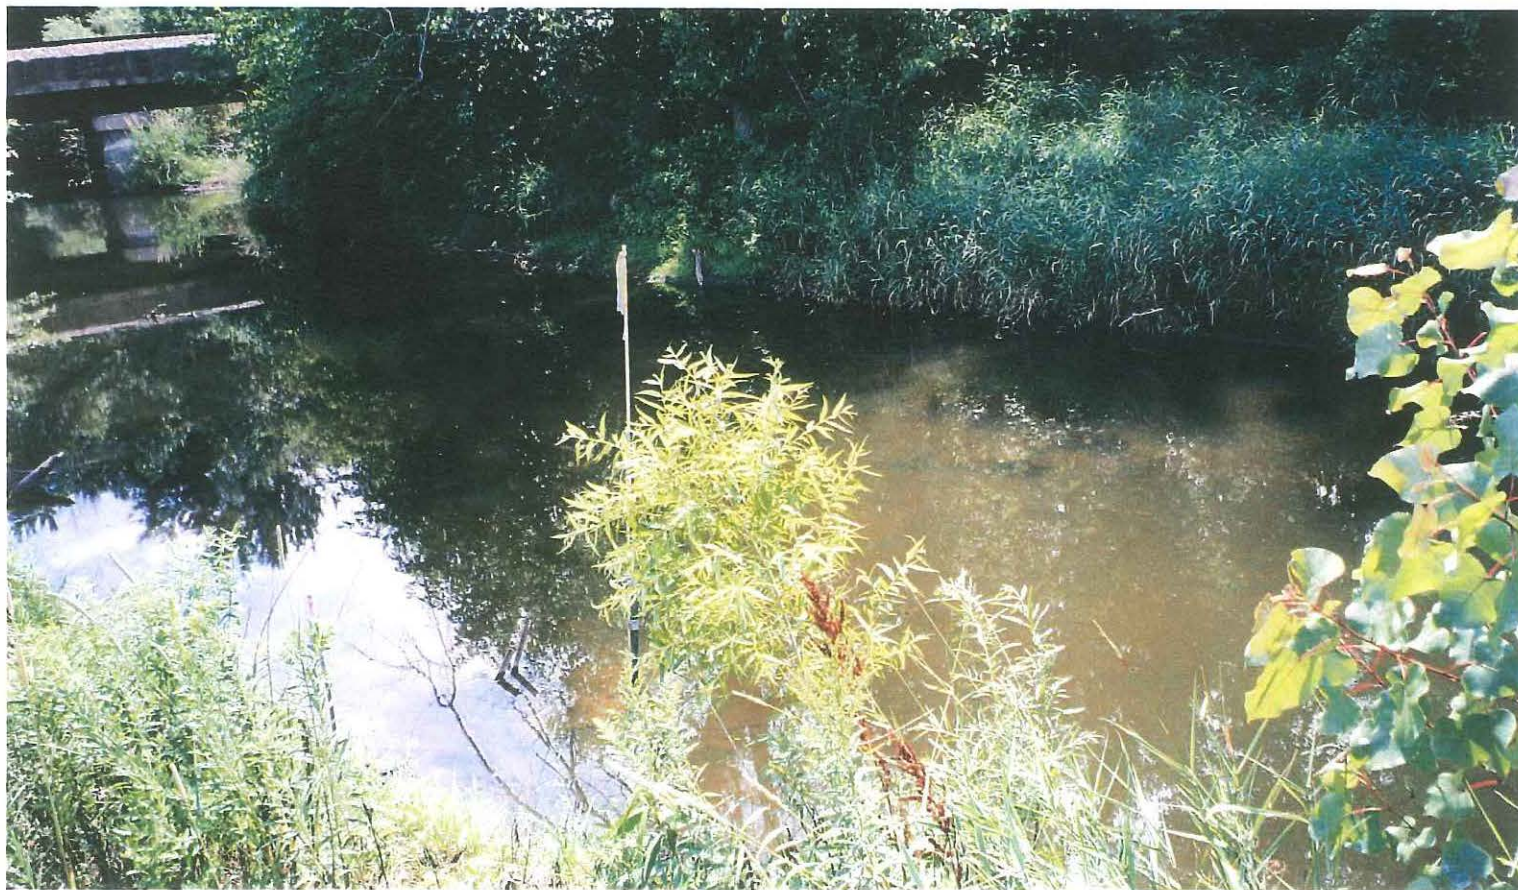
PHOTO 18

SUBJECT: Location of sediment sample SD-C1-005. Looking SSW.

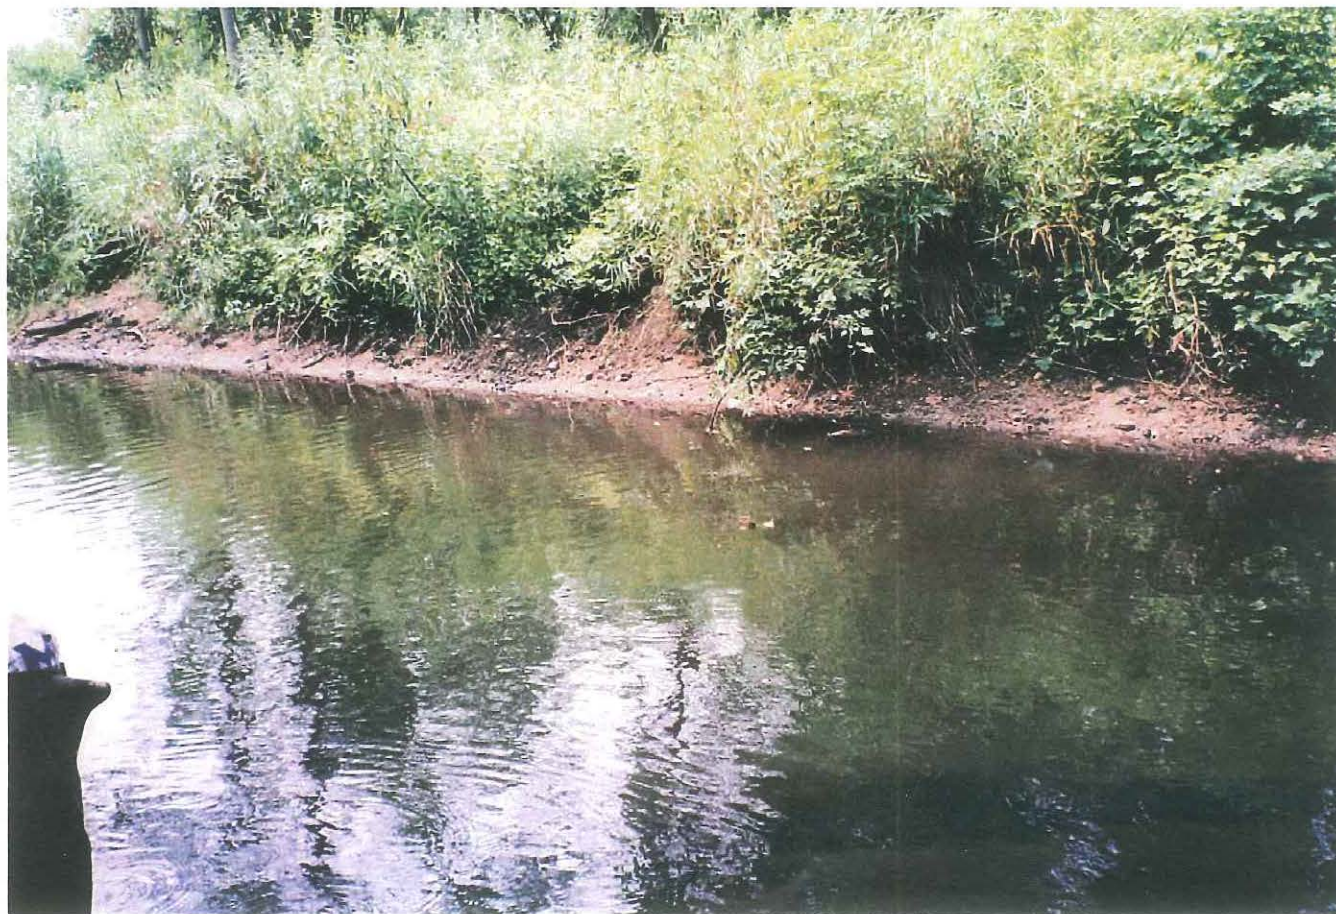
PHOTO 28  
DATE: July 25, 2007  
SITE: Former Stanley Tool Site, Fowlerville, Michigan  
SUBJECT: Location of Community Survey Station 08. Looking SW.

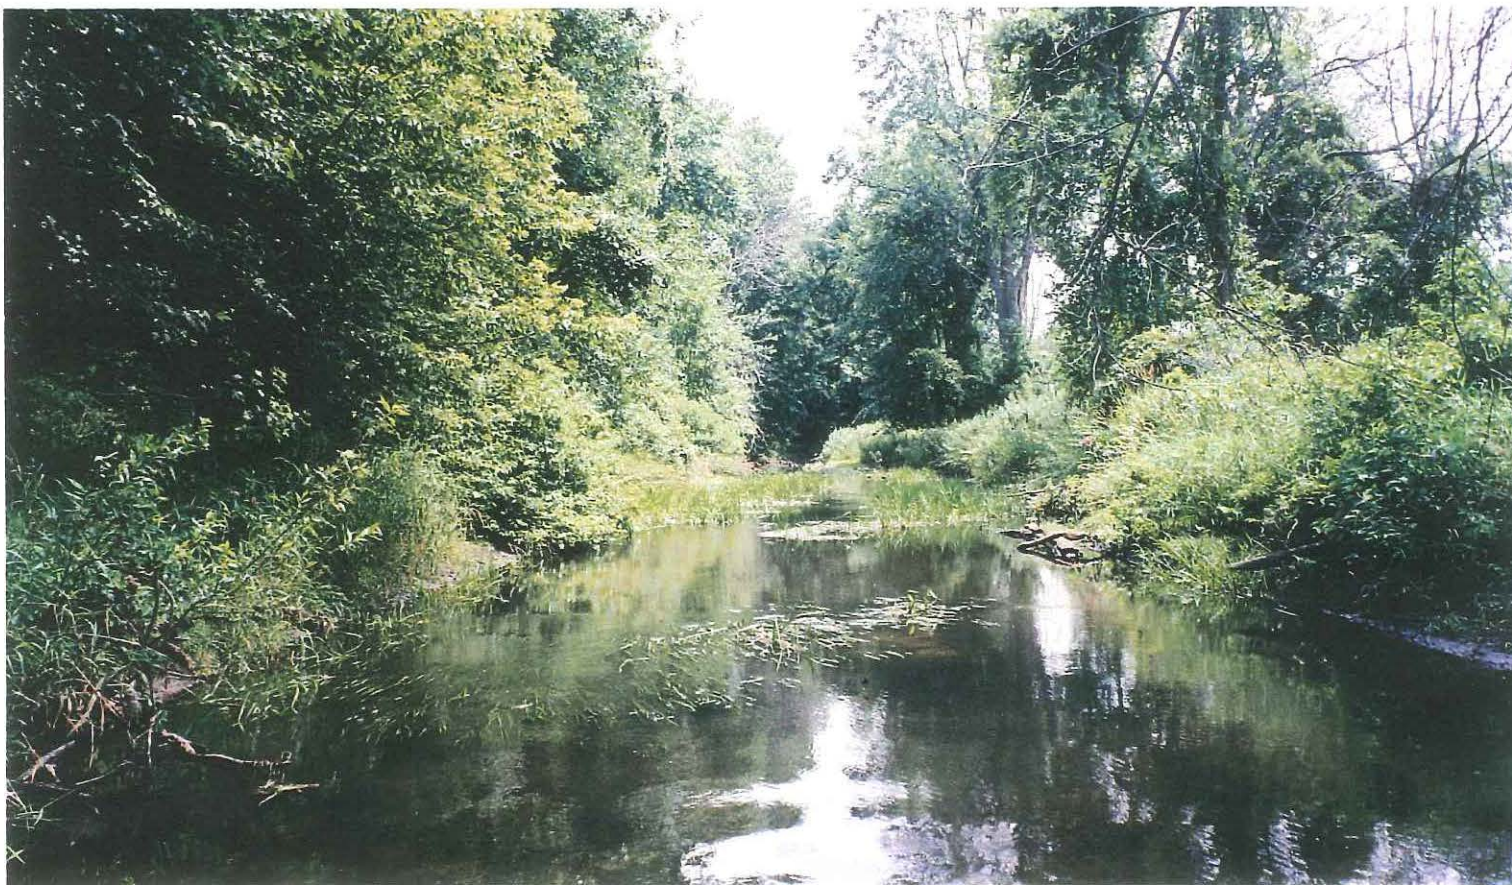
PHOTO 30

SUBJECT: River upstream of Community Survey Station 08 (further upstream from photo 29). Area of shallow riffles and floating and emergent vegetation. Looking ESE

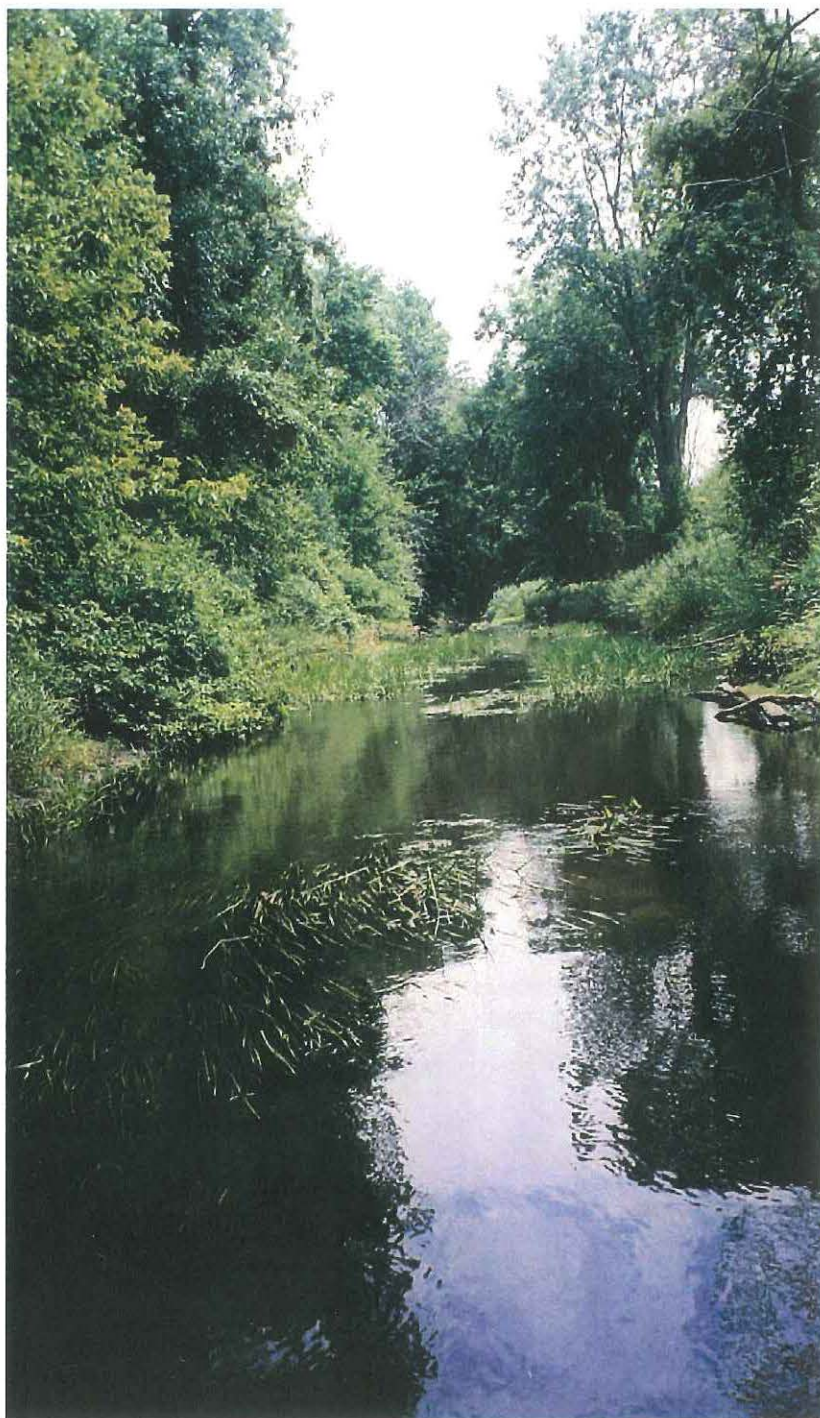
PHOTO 31

SUBJECT: River upstream of Community Survey Station 08 (further upstream from photo 28). Area of shallow riffles and floating and emergent vegetation. Looking ESE

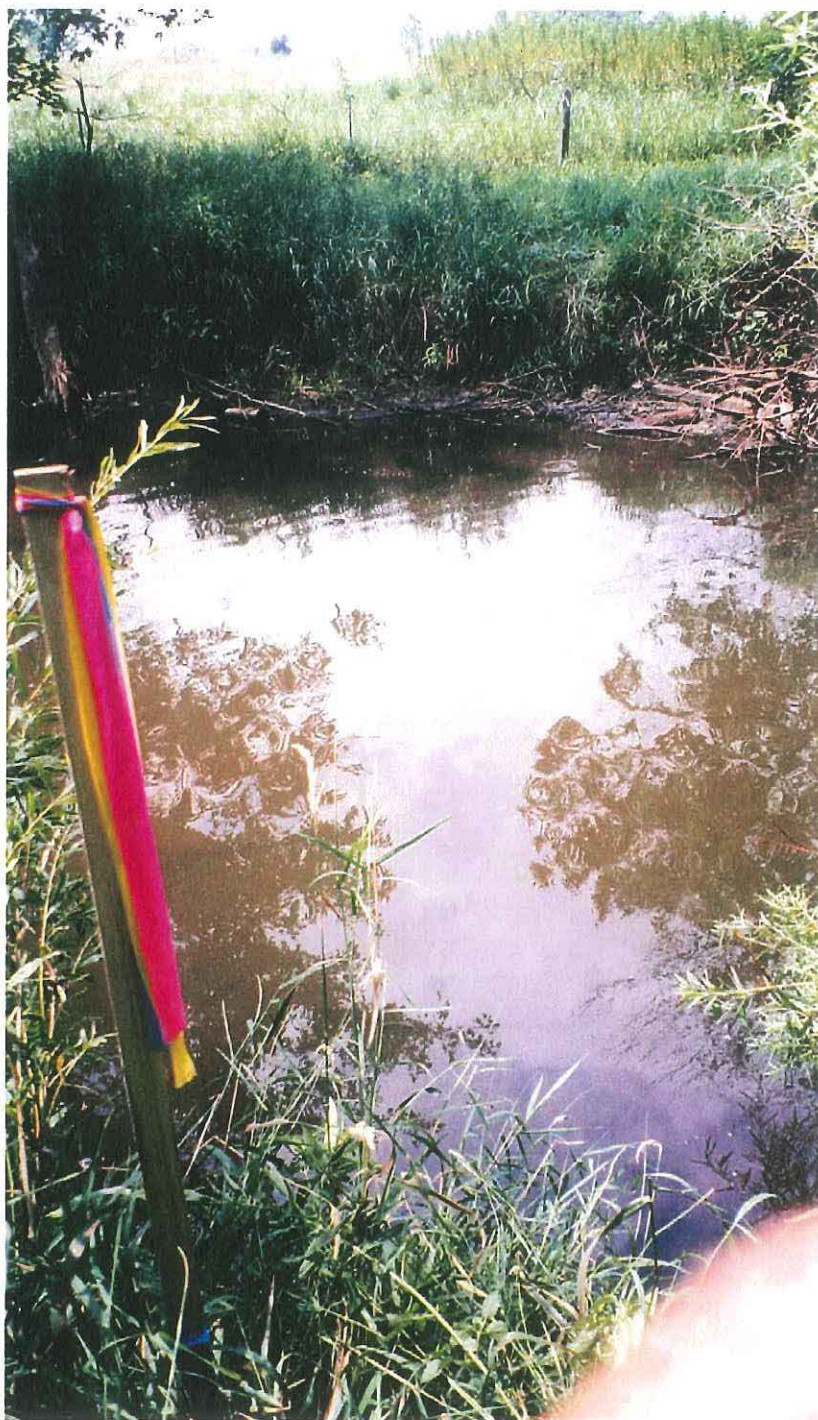
PHOTO 33  
DATE: July 25, 2007  
SITE: Former Stanley Tool Site, Fowlerville, Michigan  
SUBJECT: Location of sediment sample SE-RC-13/1-008. Looking W.

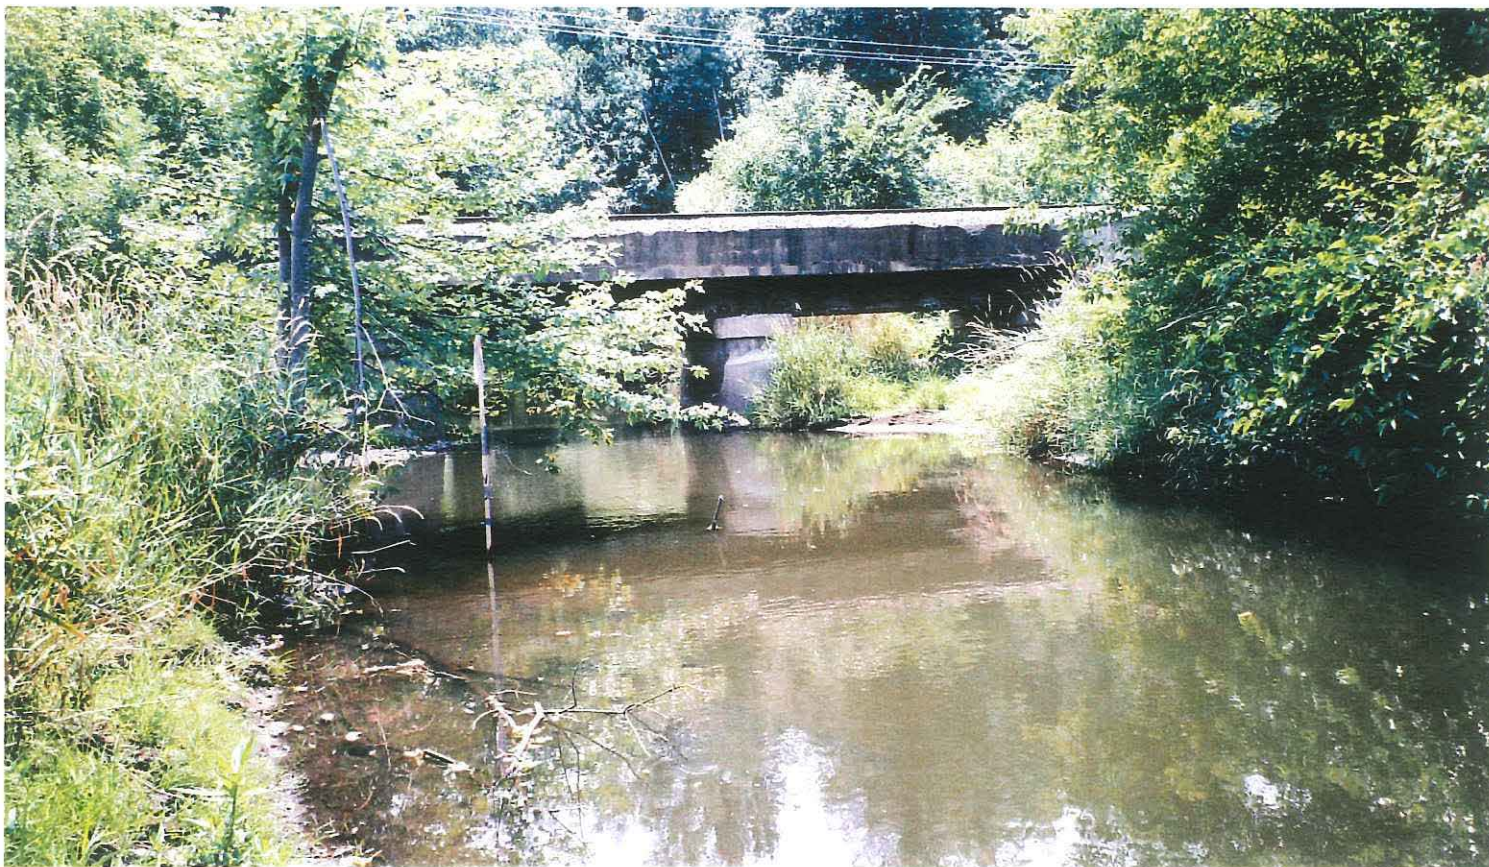
PHOTO 34

SUBJECT: Location of Sediment sample SD-A1-006 near SW corner of the former Stanley site. Community Survey Station 06 placed approximately 40 feet north of sediment sample. Looking SSW.

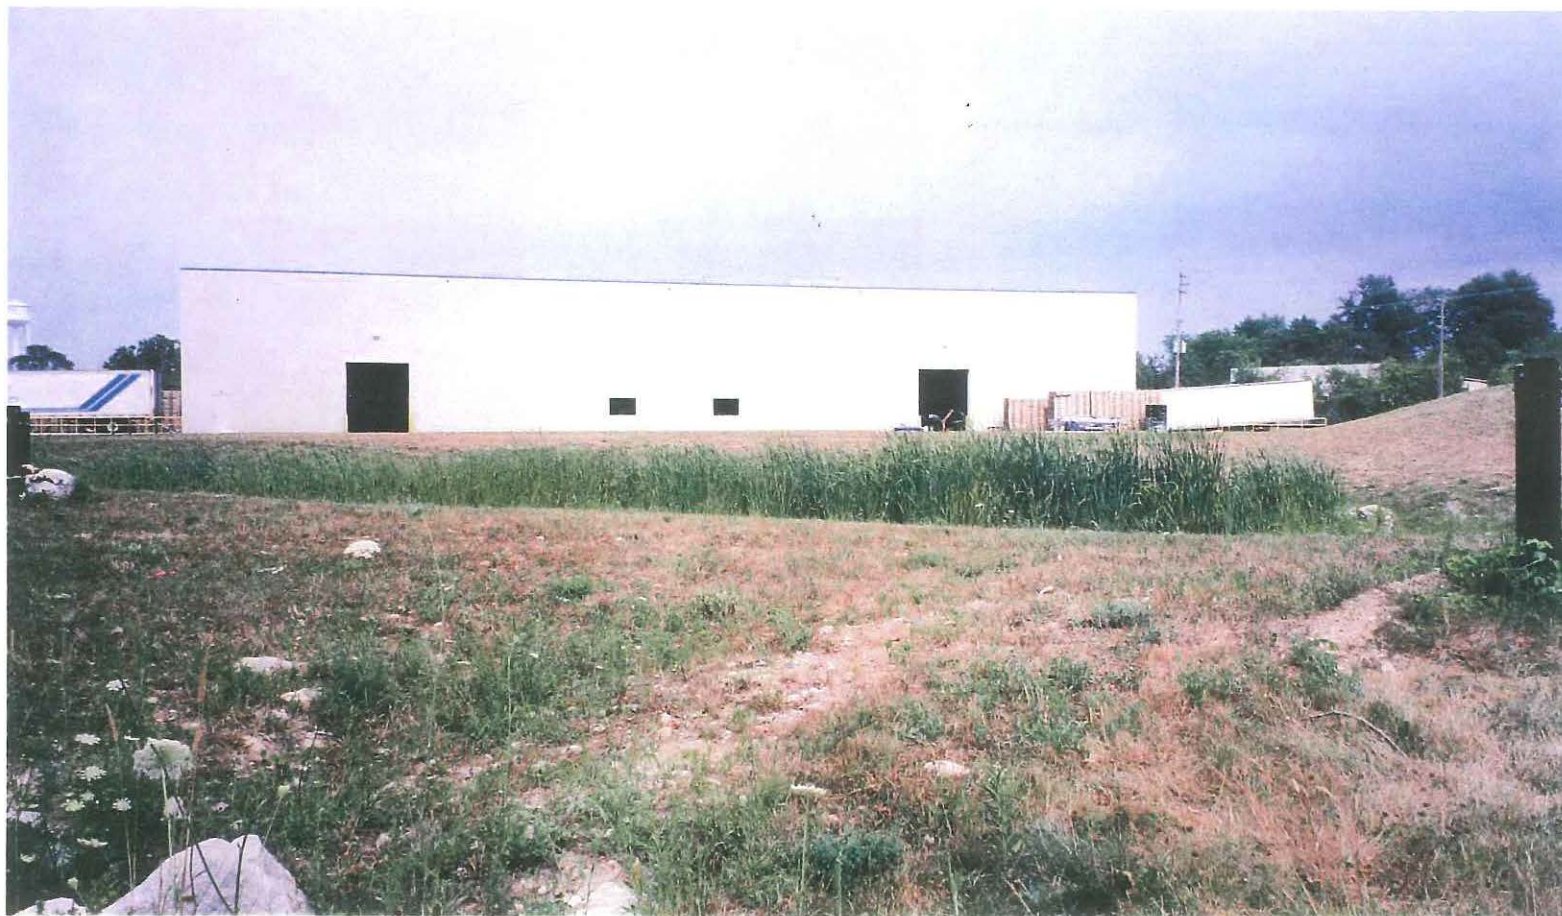
PHOTO 35

SUBJECT: View of former Stanley Site, looking E from river. Wetland area is a low portion of site that drains to the river.
